# Hagia Sophia Mosque - Istanbul

technology met with magnificence...

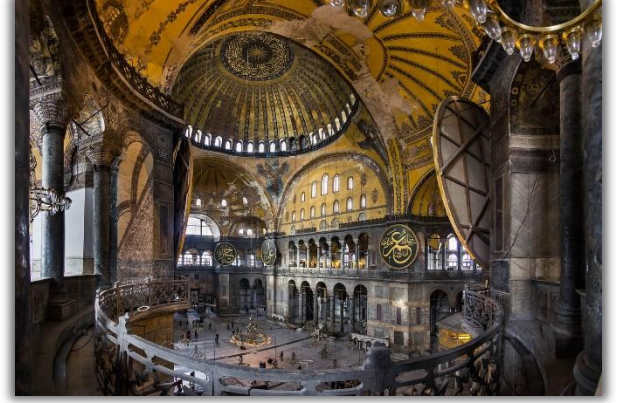
Since it is an old and historical building, in case of a fire, there is a risk of fire spreading much faster and causing damage compared to modern buildings. For this reason, the building was in need of a fire detection system that was safe, stable and would not damage its historical texture.

In addition, there was an architectural difficulty that did not allow any infrastructure work, including cabling, which could damage the structure texture. As a result of all these, the fire detection need of the building was met with Teknim Wireless Fire Alarm Systems.

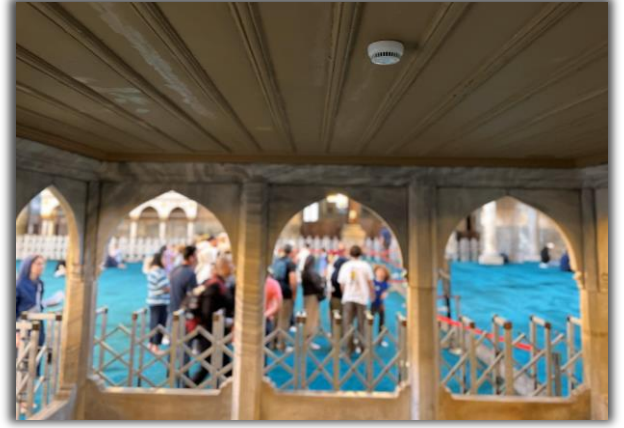
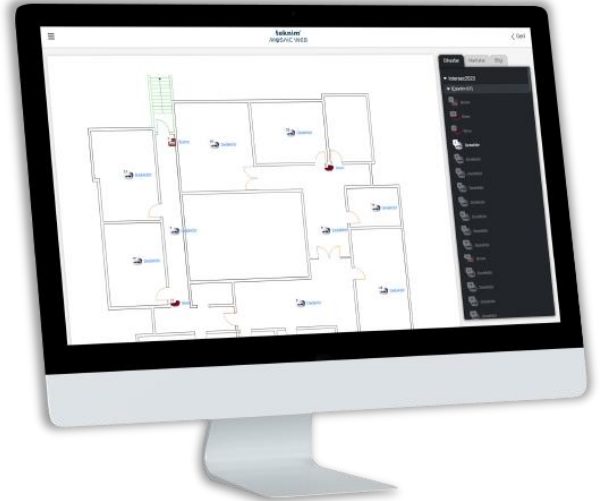
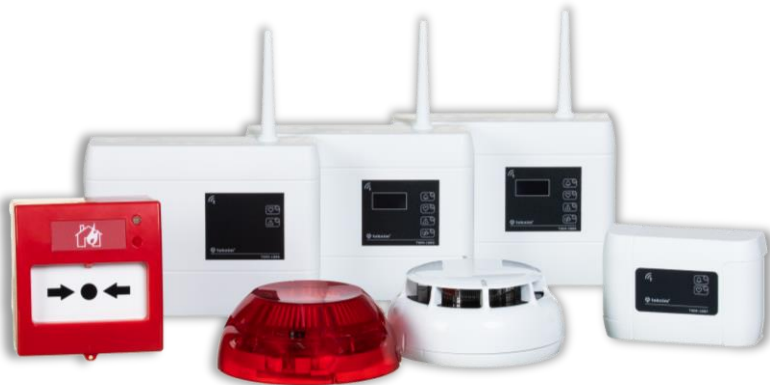
In order to prevent damage to the historical structure, the security of the environment was ensured with TWD-1850 Wireless Multiple Detectors at all points where the cabling infrastructure could not be applied.

The high dome of the prayer area in the mosque caused the need to provide detection with Beam Detectors and a module connection was required to transmit alarm-fault conditions to the Fire Alarm Panel. However, since cabling between the module and the panel was not possible, TWM-1887 Wireless I/O Modules were used to transmit alarm and fault information to the panel.

Since the wall thicknesses at many points were about 4-5 times thicker than normal buildings, this situation adversely affected the signal transmission distance of wireless devices at some points. In addition to this, the fact that there was a very dense circulation of visitors inside the mosque created a separate source of difficulty in terms of signal quality. In order to overcome both challenges, TWM-1886 Routers, which can only work with 24V DC supply and do not need any additional connection, were placed at certain points of the mosque. In this way, the thick wall structure of the mosque and the density of people negatively affecting the signal levels were eliminated.

With Mosaic Graphic Monitoring Software, the entire system is monitored live, helping the authorities to intervene quickly in possible dangerous incidents.
